RESERVE FUND STUDY REPORT

Phillips Lofts

CONDOMINIUM PLAN No. 022 2718

March 2004

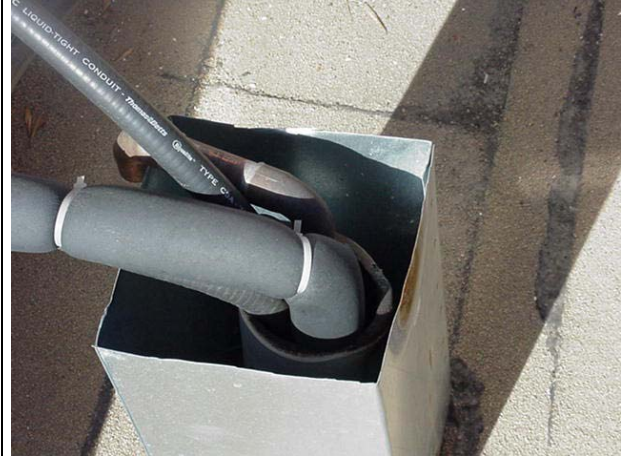
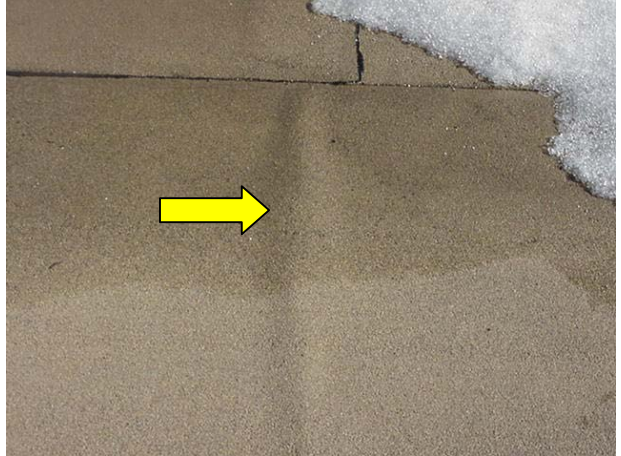
<u>ROOFING</u>	<u>Description:</u> S.B.S. Membrane	<u>Overall Condition:</u> Good
<u>Comments:</u> Overall the installation appears to be satisfactory. The only concerns of note were as illustrated in the photos below. The replacement cost has gone up significantly from the interim Report, as it was not known that the S.B.S was going to be installed along the parapet walls. As well, we were not aware of the tremendous amount of mechanical equipment that would be transversing, penetrating or sitting on the roof deck. Nor were we sure of the design of the steel decks. Replacement will be very labour intensive with all these impediments.

<p>Photograph 1</p> <p>Metal curb should have a cover, to prevent water entry.</p>	<p>Photograph 2</p> <p>The membrane has not adhered in a few locations, and soft ridges have formed. This should be picked up and monitored on future A.R.C.A. warranty inspections.</p>

<u>Specific Recommendations:</u> Metal curbs should be covered to ensure water does not penetrate the roof assembly, or the interior wall assembly. This roof has a 5-year warranty and is due this year for a re-inspection. The soft ridges should be monitored, and the required repairs made before the warranty expires. See General Recommendations.

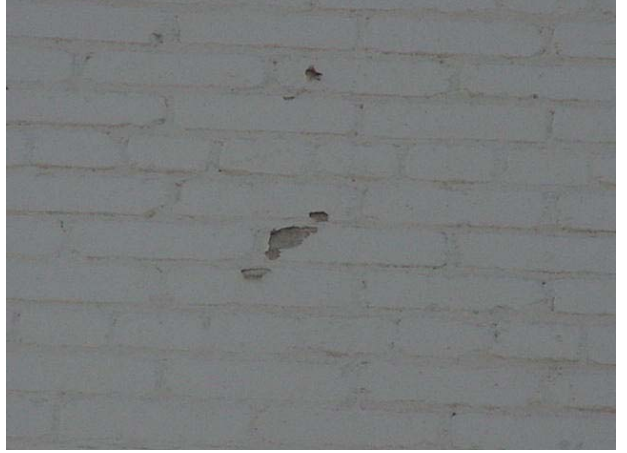
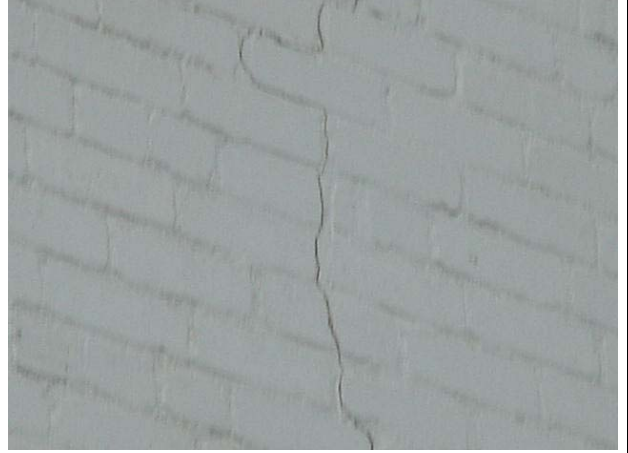
<u>BRICK FINISH</u>	<u>Description:</u> Unknown	<u>Overall Condition:</u> Fair
<p><u>Comments:</u> The brick finish on the south and east faces of the building have been painted with what appears to be an inexpensive latex product. The finish is delaminating in areas. As well, cracks in the mortar don't appear to have been filled before the paint application.</p>

<p align="center">Photograph 3</p>	<p align="center">Photograph 4</p>	
<p><u>Specific Recommendations:</u> The brick finish is for aesthetic purposes only, and it is not easy to say how long before the current finish is going to be too unsightly. For the purposes of this Report, a budget figure of \$2.00 per sq. ft. has been scheduled for 2007. This is for the application of 2 coats of a top quality acrylic product following power washing of the current finish.</p>		
<u>BALCONY DECKING</u>	<u>Description:</u> Stamped Steel	<u>Overall Condition:</u> Fair

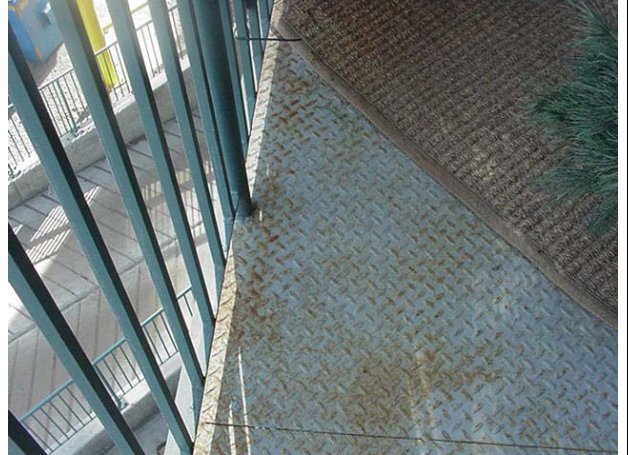
<p align="center">Photograph 5</p>

<p><u>Comments:</u> The balcony decks should never need replacing, however, they should occasionally be painted with a rust-inhibitive coating. It is not known what coating was originally applied, but on the one balcony inspected, large amounts of rust are already visible. As well, an area rug had been placed over the deck. Without a proper coating, the moisture retained in the carpeting will hasten the formation of rust.</p>

<p><u>Specific Recommendations:</u> Balcony decks should be painted with a rust-inhibitive. If unit owners wish to use area rugs, they should be reminded to inspect the decking on a regular basis to ensure that the coating is still effective.</p>		
<u>BALCONY & MISCELLANEOUS RAILINGS</u>	<u>Description:</u> Painted Steel	<u>Overall Condition:</u> Good
<p><u>Comments:</u> No anomalies noted or reported. These railings should never need replacement, however, occasional painting with a rust-inhibitive product will be required.</p>		
<p><u>Specific Recommendations:</u> See General Recommendations.</p>		
<u>BALCONY SUPPORTS</u>	<u>Description:</u> Painted steel	<u>Overall Condition:</u> Good
<p><u>Comments:</u> As with the railings, the support posts and beams will require occasional painting with a rust-inhibitive paint.</p>		
<p><u>Specific Recommendations:</u> See General Recommendations.</p>		
<u>WINDOWS</u>	<u>Description:</u> Front - Wood frame Remainder - Wood frame with aluminum exterior	<u>Overall Condition:</u> Good

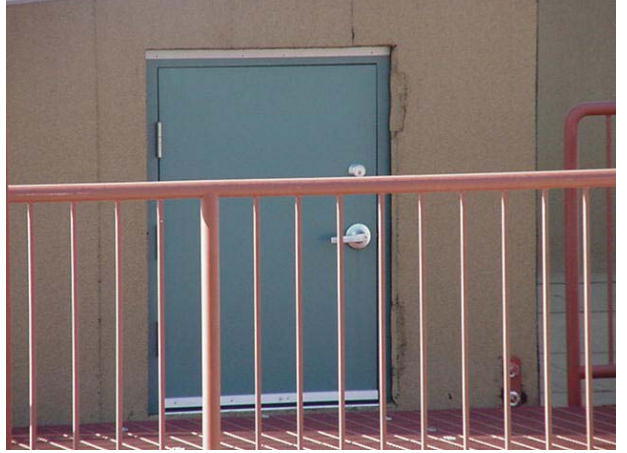
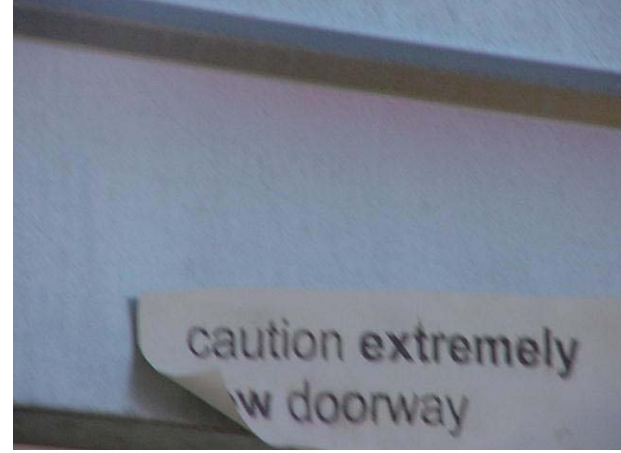
<u>PENTHOUSE ROOF DOORS</u>	<u>Description:</u> Insulated steel	<u>Overall Condition:</u> Good
<u>Comments:</u> At the time of the initial inspections for the interim report, all the penthouse roof doors were well below the typical height of 82". Current inspection noted that one of the door heights has been corrected, but 3 are less than 5ft. high.

9. It is recommended that all parkade pillars have protective corner capping installed.
10. Further investigation into whether or not the penthouse roof doors need to meet certain Building Code requirements is recommended (if not already done so).

Photograph 6	Photograph 7	
<u>Specific Recommendations:</u> Further investigation into whether or not these doors need to meet certain Building Code requirements is recommended (if not already done so). See General Recommendations.		
<u>EXTERIOR SECURITY ENTRANCE DOORS</u>	<u>Description:</u> Solid wood Insulated steel	<u>Overall Condition:</u> Good
<u>Comments:</u> No anomalies noted or reported.		
<u>Specific Recommendations:</u> See General Recommendations.

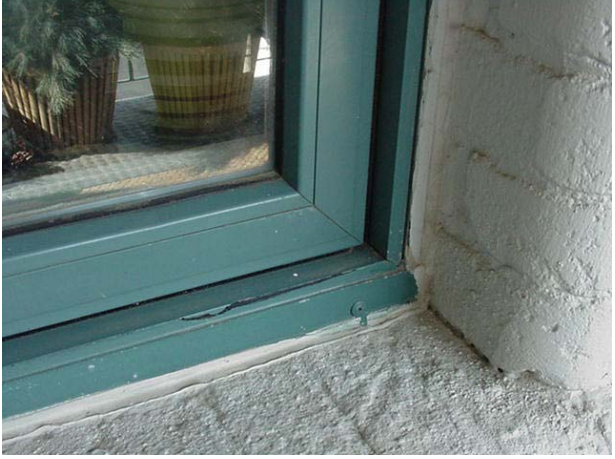
<u>SEALANT</u>	<u>Description:</u> Varied	<u>Overall Condition:</u> Good
<p><u>Comments:</u> Sealant is used to close spaces between components, helping eliminate the movement of air and water past the joints. Sealant was found around the perimeter of all windows and doors. No problems were noted with the areas inspected.</p>

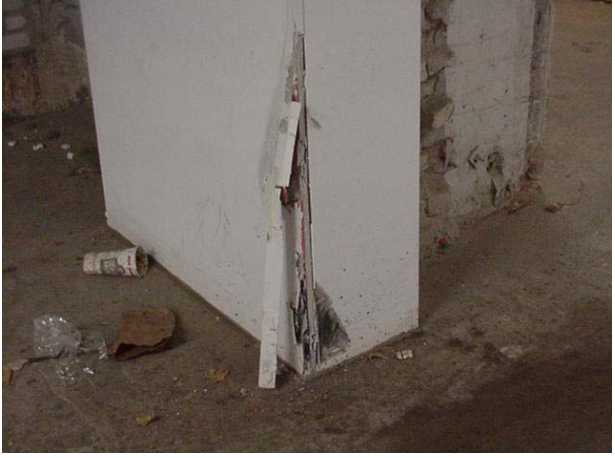
<p align="center">Photograph 9</p>

<p><u>Comments:</u> Columns in parkade have been clad with painted drywall. The majority have had steel protective corners installed, however the column just inside the overhead door has not, and unfortunately, has been struck and damaged.</p>

<u>Specific Recommendations:</u> It is recommended that all parkade pillars have protective corner capping installed. See General Recommendations.		
<u>CEILING FINISH</u>	<u>Description:</u> Paint	<u>Overall Condition:</u> Good
<u>Comments:</u> Due to the amount of exposed piping along the ceilings, painting will be rather labour intensive. Costs have been increased from the interim report.		
<u>Specific Recommendations:</u> See General Recommendations.		
<u>FLOORING</u>	<u>Description:</u> Terrazzo Carpet Ceramic Tile Linoleum Tile	<u>Overall Condition:</u> Good
<u>Comments:</u> The terrazzo flooring in the front lobby is original, and should last the life of the building. Although ceramic tile can last 35 to 40 years, re-grouting may be necessary after 20 to 25 years.		
<u>Specific Recommendations:</u> See General Recommendations.		
<u>COMMUNITY MAILBOXES</u>	<u>Description:</u> Stainless Steel - Recessed	<u>Overall Condition:</u> Good

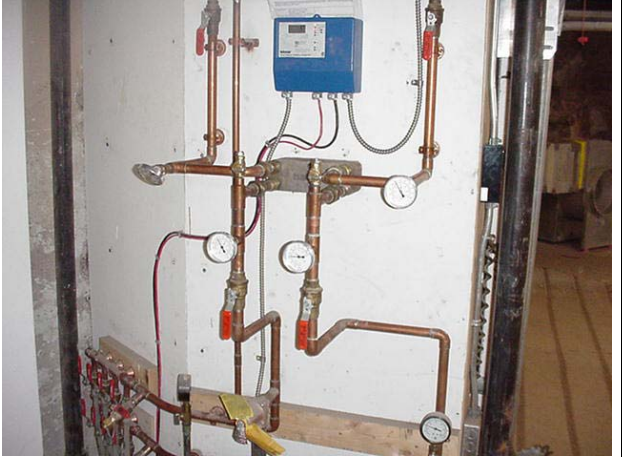
<u>GLYCOL RAMP HEAT</u>	<u>Description:</u> Grundfos recirculating pump, controls, heat exchanger and piping	<u>Overall Condition:</u> Good
<u>Comments:</u> During site review it was noted that one of the pressure gauges has been damaged and is leaking.

8. It is recommended the pressure gauge on the glycol ramp heat be repaired and that the Board consider the installation of a protective cage in front of the motor and controls.

Photograph 11		
<u>Specific Recommendations:</u> It is recommended that this be repaired and that the Board consider the installation of a protective cage in front of the motor and controls.		
<u>PARKADE DOOR</u>	<u>Description:</u> Double steel insulated door and controller	<u>Overall Condition:</u> Good
<u>Comments:</u> No problems or anomalies noted at the time of site review. It is recommended that periodic servicing of the door and controller be completed to help insure proper operation.

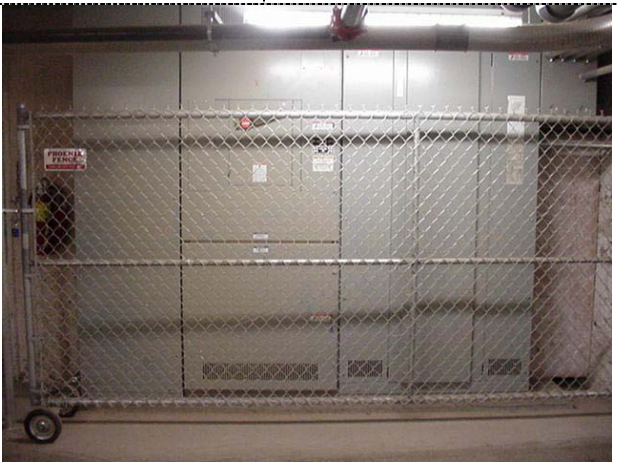
<p><u>ELECTRICAL DISTRIBUTION</u></p>	<p><u>Description:</u> Located in the parkade area</p>	<p><u>Overall Condition:</u> Fair</p>
<p><u>Comments:</u> The electrical distribution system has been installed open to the parkade area. This type of installation will require additional maintenance to help ensure its life cycle.</p>

6. Step differential between parkade storeroom and hallway is a potential tripping hazard and should be graded.
7. It is recommended that regular cleaning and infrared scans of the electrical distribution system be completed to help prevent possible anomalies from occurring.

<p><u>Specific Recommendations:</u> It is recommended that regular cleaning and infrared scans of the electrical distribution system be completed to help prevent possible anomalies from occurring.</p>		
<p><u>LIGHTING</u></p>	<p><u>Description:</u> Use of both energy efficient and regular lighting fixtures</p>	<p><u>Overall Condition:</u> Good</p>
<p><u>Comments:</u> It was noted during review that the exit lights of the building are not energy efficient. Other lighting may have energy savings if replaced.</p>

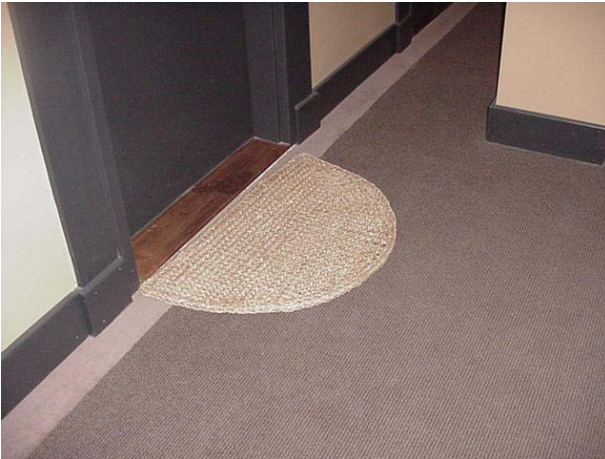
3. Fire extinguisher and hose in parkade should have proper housing.
4. Scatter rugs in hallways are in violation of the 1997 Fire Code.
5. Exit signs in parkade should be repaired and illuminated.

Scatter rugs in hallways are in violation of the 1997 Fire Code.

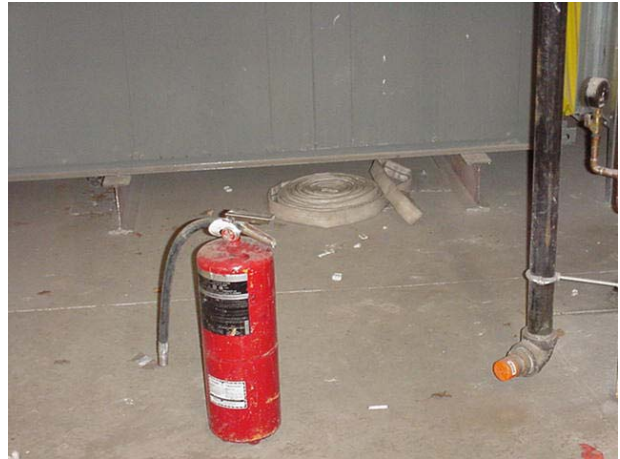
Fire extinguisher and hose should have proper housing.

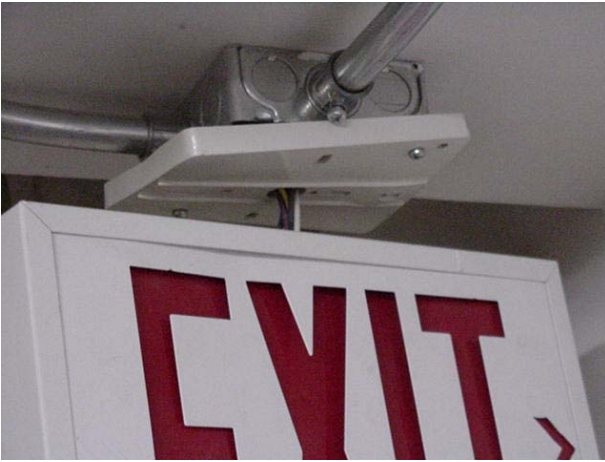
Exit sign in parkade is not securely fastened and is not illuminated.

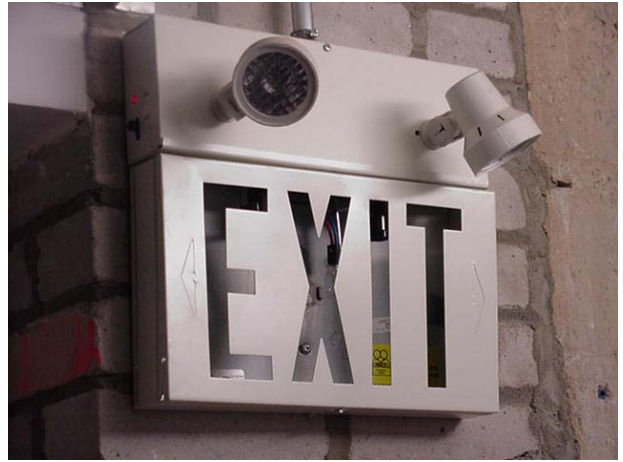
Exit sign in parkade is broken and not illuminated.

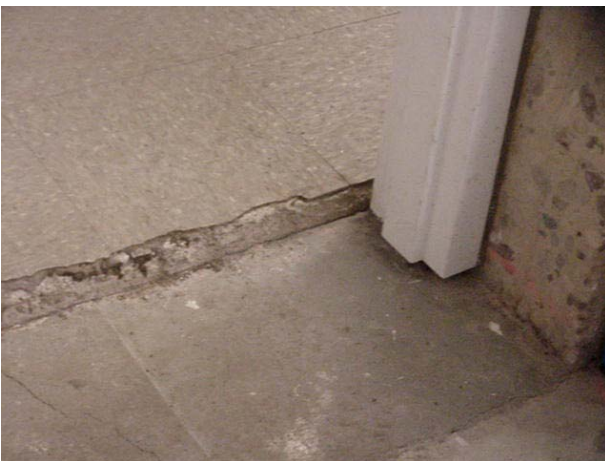
Step differential between parkade storeroom and hallway is a potential tripping hazard and should be graded.

Uneven walking surfaces and potential tripping hazards should be repaired as soon as possible to limit the Corporation's exposure to liability.

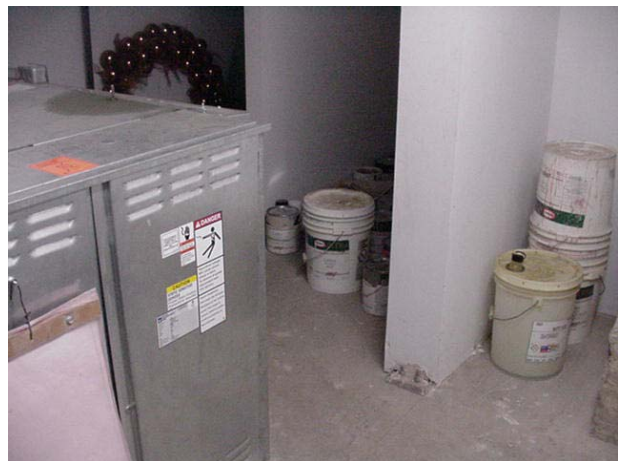
1. It is recommended that the furnaces be in operation at all times as they are also for hallway pressure in the event of a fire.
2. Storage of items in elevator machine room is in violation of the 1997 Fire Code and they should be moved to a different location.

Storage of items in elevator machine room is in violation of the 1997 Fire Code and should be removed to a different location.

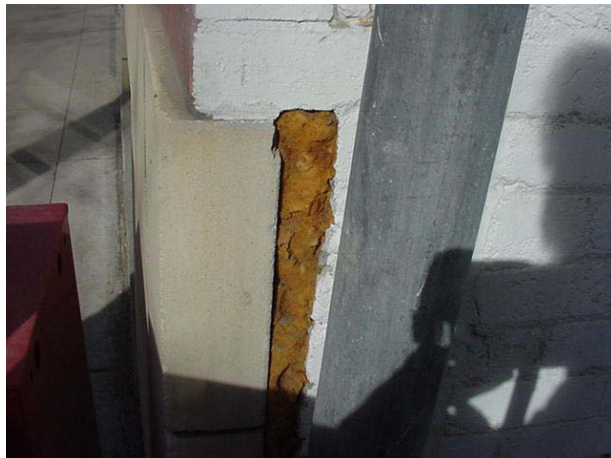
An area of exposed insulation was noted on the southwest corner of the building, and should be covered and sealed.
