RESERVE FUND STUDY REPORT

Phillips Lofts

CONDOMINIUM PLAN No. 022 2718

March 2004

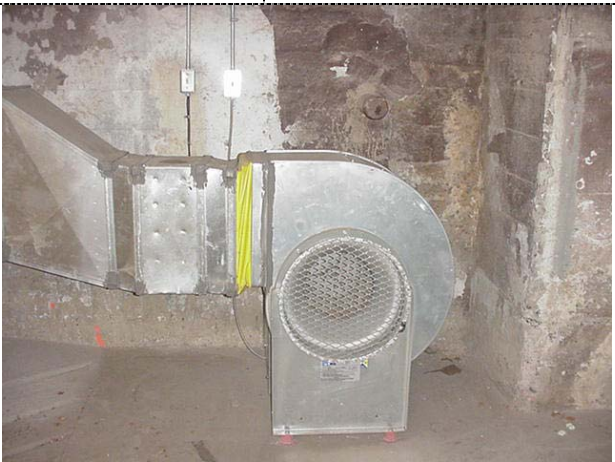
<u>PARKADE EXHAUST FAN</u>	<u>Description:</u> Exhaust fan	<u>Overall Condition:</u> Good
<u>Comments:</u> This exhaust fan works in conjunction with the parkade make-up air unit to ensure regulated air pressure in the parkade.

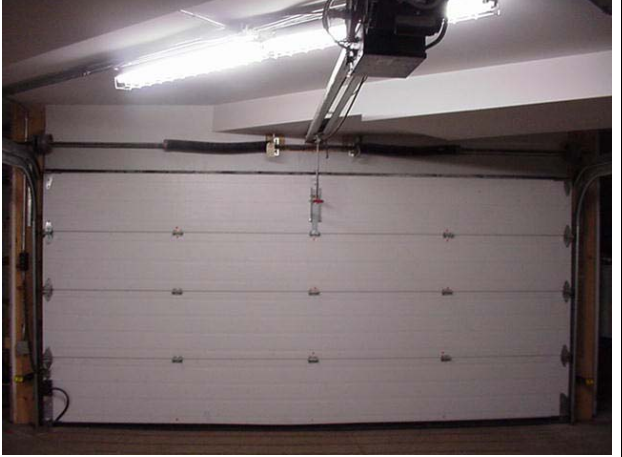
Photograph 12

Photograph 11		
<u>Specific Recommendations:</u> It is recommended that this be repaired and that the Board consider the installation of a protective cage in front of the motor and controls.		
<u>PARKADE DOOR</u>	<u>Description:</u> Double steel insulated door and controller	<u>Overall Condition:</u> Good
<u>Comments:</u> No problems or anomalies noted at the time of site review. It is recommended that periodic servicing of the door and controller be completed to help insure proper operation.

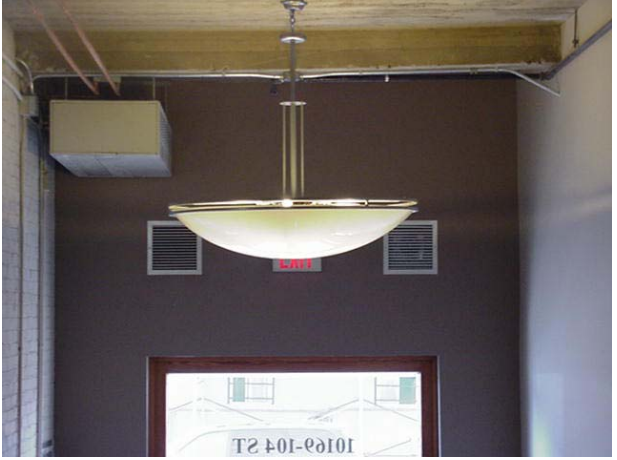
<p><u>Specific Recommendations:</u> It is recommended that regular cleaning and infrared scans of the electrical distribution system be completed to help prevent possible anomalies from occurring.</p>		
<p><u>LIGHTING</u></p>	<p><u>Description:</u> Use of both energy efficient and regular lighting fixtures</p>	<p><u>Overall Condition:</u> Good</p>
<p><u>Comments:</u> It was noted during review that the exit lights of the building are not energy efficient. Other lighting may have energy savings if replaced.</p>

<p><u>Specific Recommendations:</u> It is recommended that the Board consider having an Energy Audit performed to capitalize on all possible energy savings.</p>

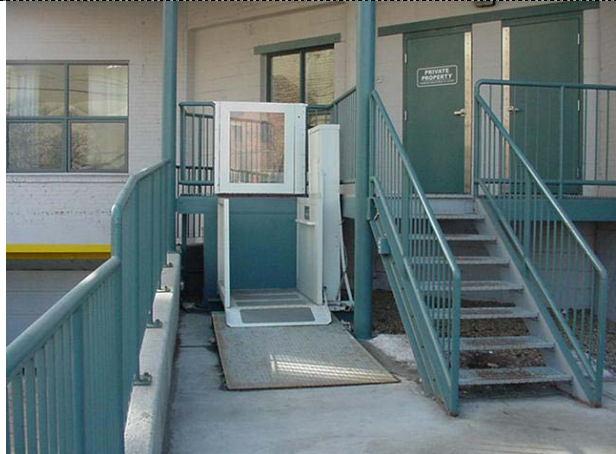
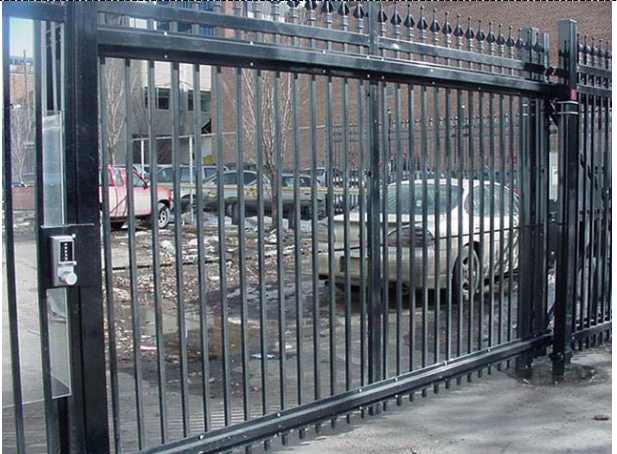
Photograph 15		Photograph 16

<u>ELEVATORS</u>	<u>Description:</u> Three 40 HP hydraulic elevators	<u>Overall Condition:</u> Good
<u>Comments:</u> No anomalies noted or reported with the elevator.		
<u>FIRE ALARM SYSTEM</u>	<u>Description:</u> Horn / strobes, pull stations, smoke detectors/ heat sensors and Mircom panel.	<u>Overall Condition:</u> Good
<u>Comments:</u> The fire alarm system appears to meet the 1997 Alberta Fire Code and no anomalies were noted.		
<u>INTERCOM SYSTEM</u>	<u>Description:</u> Mircom	<u>Overall Condition:</u> Good
<u>Comments:</u> No anomalies noted or reported. It is recommended that periodic cleaning be completed to help protect the life cycle of the intercom.		
<u>SECURITY GATES AND WHEELCHAIR LIFT</u>	<u>Description:</u> Two motor controls for access into parking area and motor control for wheelchair lift.	<u>Overall Condition:</u> Good
<u>Comments:</u> Security gates have been added to the parking area to the south of the building and a wheelchair lift has been added to provide handicap access to the building. No problems were noted at the time of site review.
